VEHICLE ENGINEERING

STS-104 FLIGHT READINESS REVIEW

Presenter:
	Organization/Date: Orbiter/06-28-01

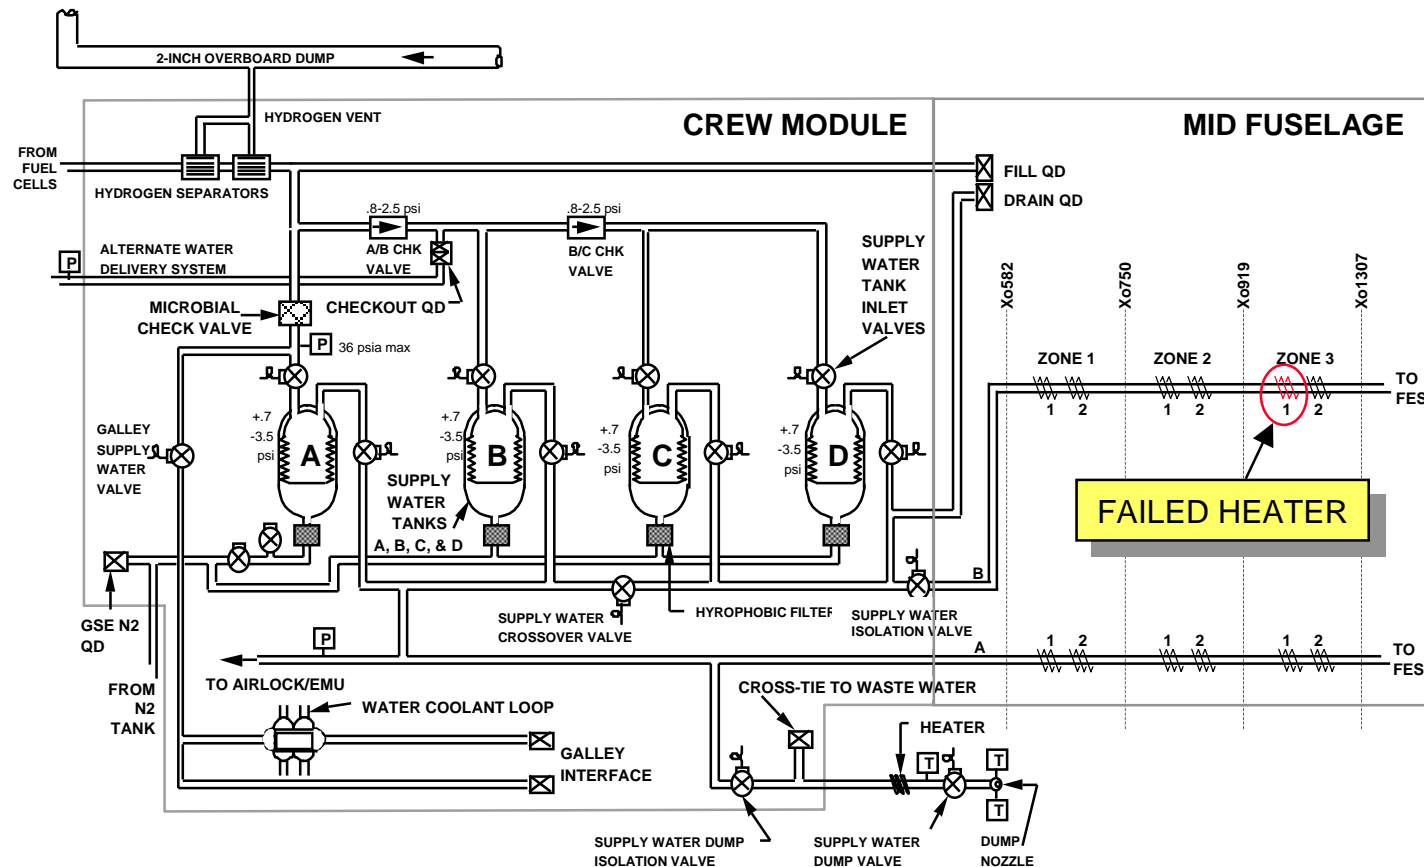
SUPPLY WATER SYSTEM

- FES B (stbd) supply H₂O feedline heater 1 zone 3 failed off and the line temperature (V63T1875A) dropped to about 52°F

- Water line temperature in zone 3 drifted to around 52°F at MET 000:13:00 (vs 65F to 90F typical) indicating heater failure
 - No heater cycles seen following application of heater string 1 power post-launch
- Heater is required to prevent water line freezing in cold attitudes
- There are two heater strings per feedline

- Post-flight troubleshooting found a broken wire at the heater ground point

- FES heater string operation was verified as part of in flight checkout OMRS file IX requirements during the last OV-104 mission (STS-98)
- In the event of a heater failure, the redundant heater string may be used
- With loss of both heater strings, a contingency procedure to purge the affected line is available to prevent freezing and allow recovery of the system for entry

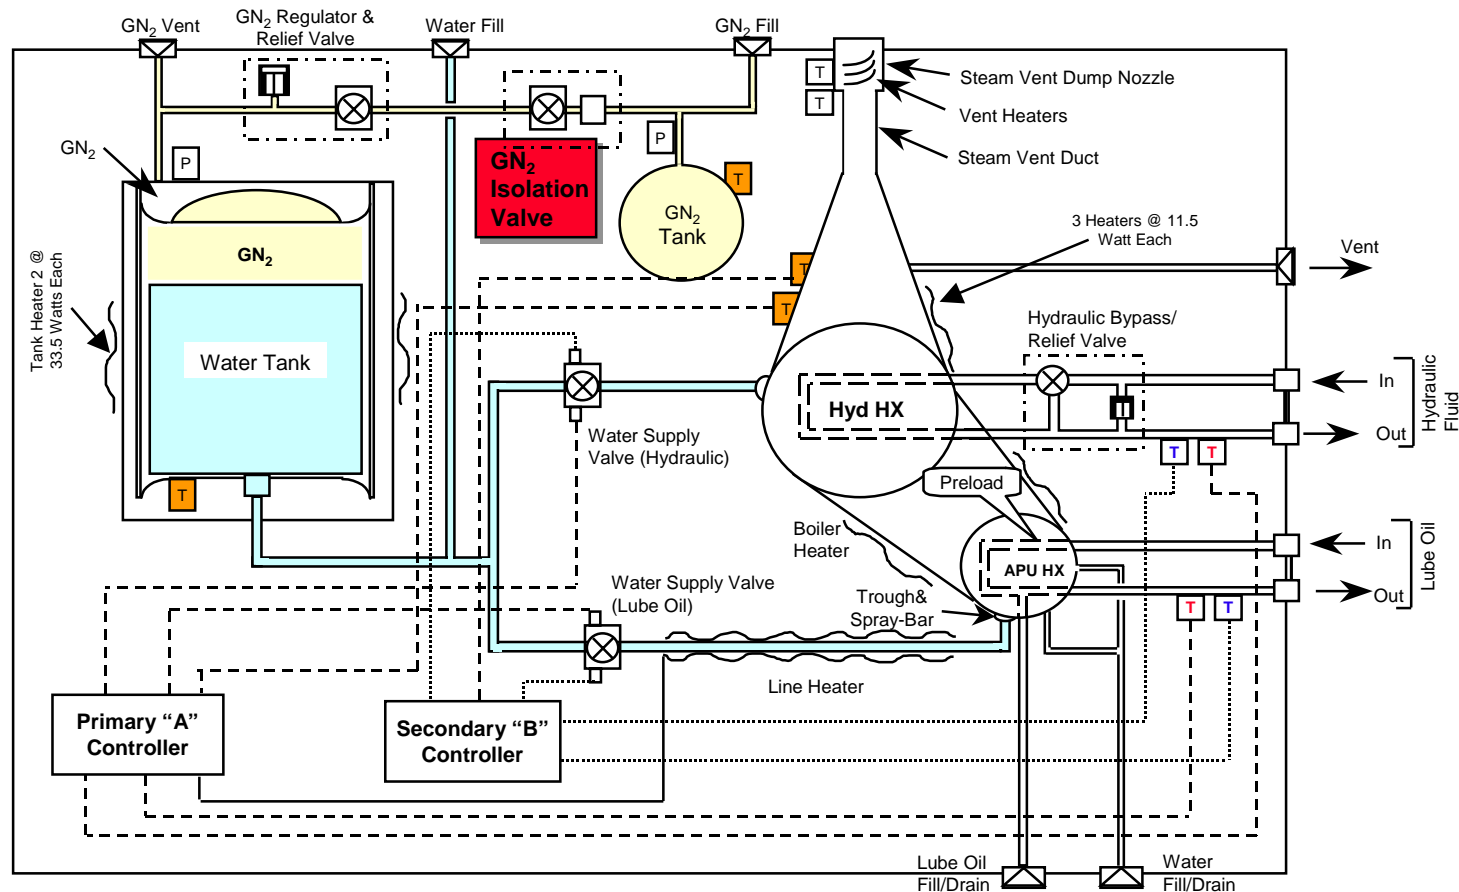
WATER SPRAY BOILER SYSTEM SCHEMATIC

- Post-flight troubleshooting has isolated the source of the heat to the GN₂ isolation valve
 - A failure within the controller caused the isolation valve to remain powered and act as a heater, supplying 37.5 watts of energy
 - Multiple single point failures within the controller can produce this failure; none are common to both A and B controller
- The controller has been removed and routed to NSLD for TT&E
 - The failure has been isolated to circuit board #8 where the output current for the GN₂ isolation valve is always on
 - The circuit board will be replaced with a spare
 - Failure analysis will begin on the failed circuit board

- OV-104 WSB operation was verified per OMRS test requirements
- In the event of a similar failure, the WSB will be switched to the alternate controller

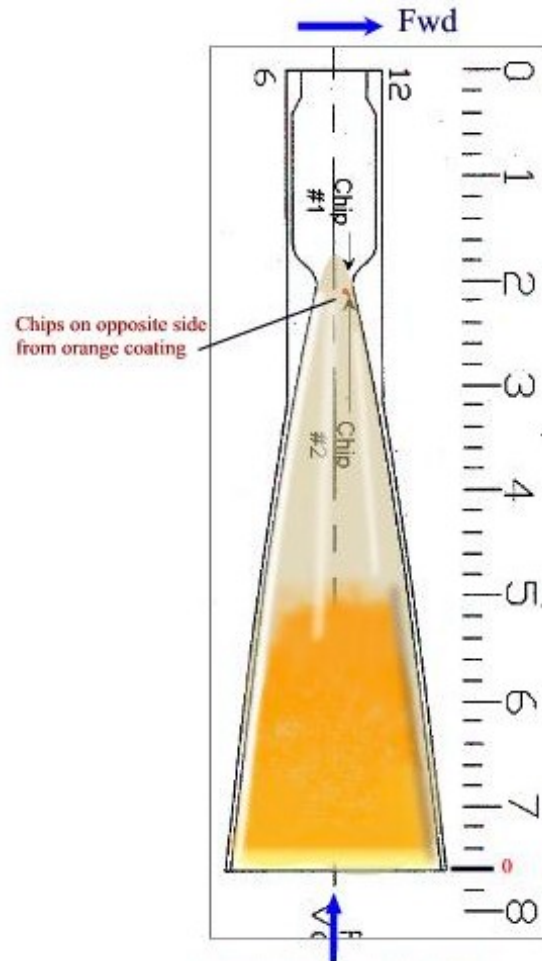
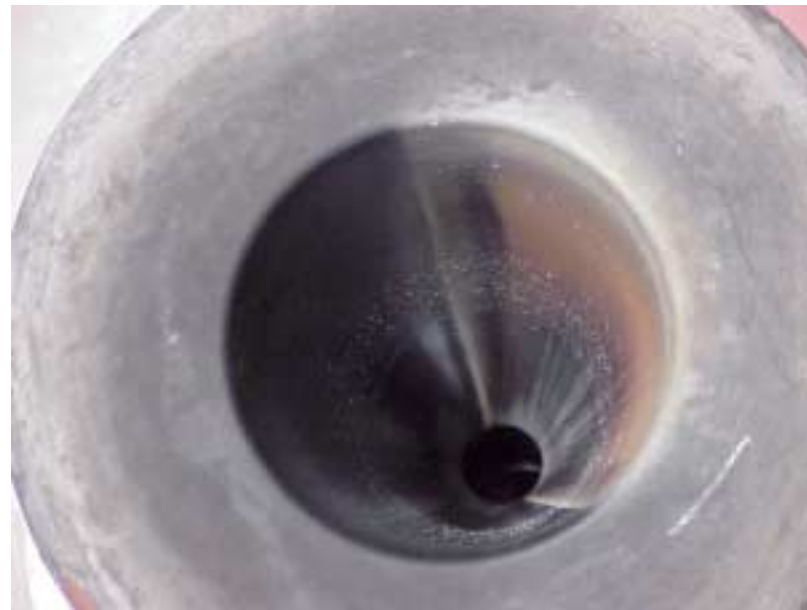
VERNIER THRUSTER R5D S/N 401

- Injector temperatures were nominal
- Prior to occurrence, R5D had been used for two reboost sessions with nominal Pc
- Unable to verify from flight data whether low Pc indications were accurate representations of actual chamber pressure
 - Indications may be instrumentation only
- ALT DAP used during crew sleep to avoid alarm if thruster failed
- Possible causes of low Pc:
 - Restriction in oxidizer or fuel valve orifice
 - Combustion products (FORP) in Pc tube
- Vernier thruster Pc tubes are flushed at OMDP

- Visual inspection found bright powdery-orange area in divergent part of nozzle
 - Unable to obtain sample (would not scrape off using teflon tool or come off using IPA/wipe)
- Borescope inspection of combustion chamber was performed
 - No sign of contamination on injector
 - No evidence of blockage at Pc port
 - Existing chip in throat (which was .04" x .04" previously) is now .08" x .09"
- The thruster was removed and there were no external abnormalities on Pc tube
- The thruster was shipped to WSTF
 - TT&E is underway, initial results expected by 7/9/01

- Complete TT&E at WSTF
- For upcoming missions, a vernier thruster with the same signature will not be fired until the failure analysis is complete and the cause is understood

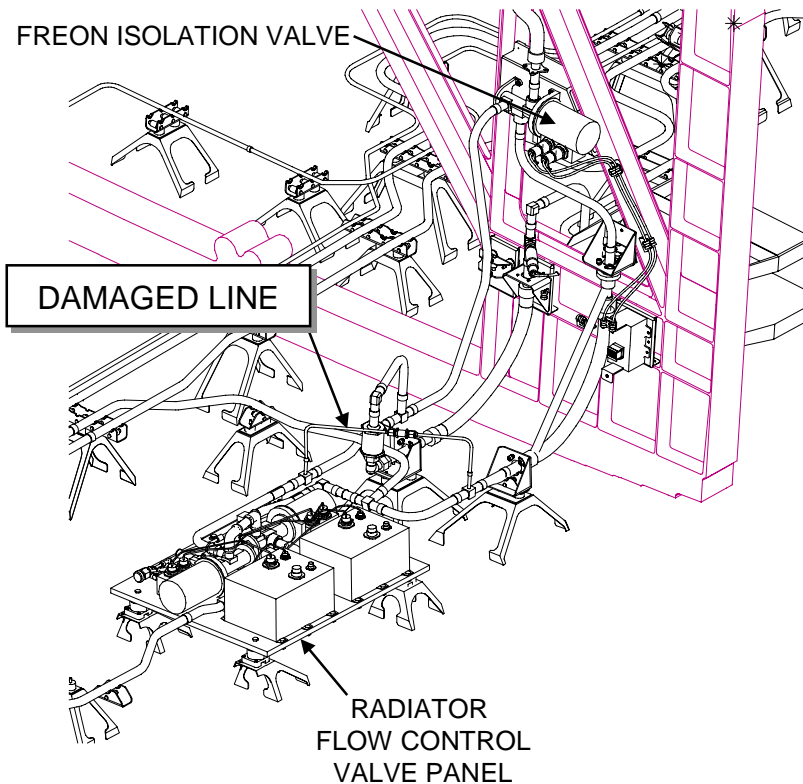
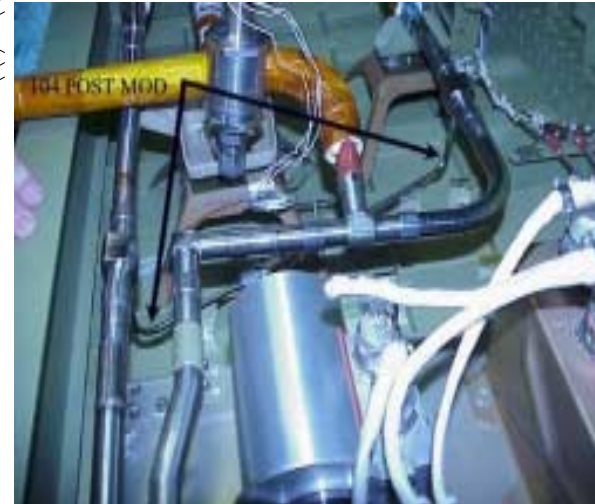
LINE REROUTED UNDER EXISTING PLUMBING

- Reroutes the freon loop #2 (starboard) 1/4" relief line which was susceptible to damage during maintenance operations

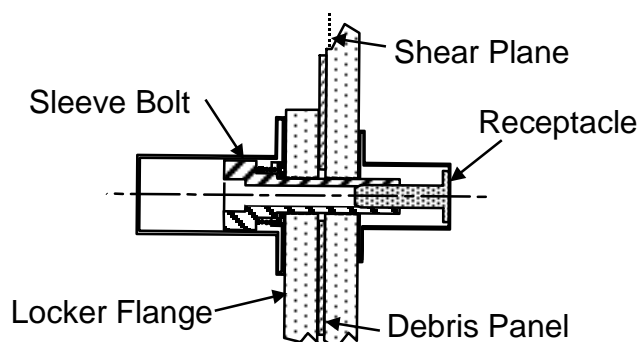
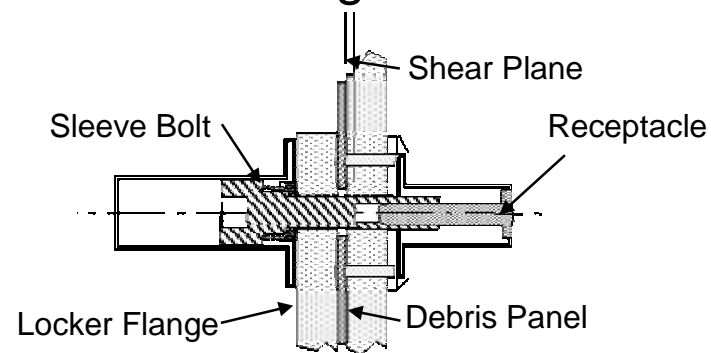
- Previous design of mid-deck locker sleeve bolts do not meet 20g crash load requirement at lower positions (OVEI waiver approved)
- The lockers, debris panels and thermal panels have been modified to ensure that the solid fastener cross-section is positioned at the locker-to-structure shear plane
 - Lockers were simultaneously modified to add double acting latches and shims for better fit of fire port extension hose
- 18 lockers as well as MA9N soft stowage bag mounting panel have been modified to the new configuration

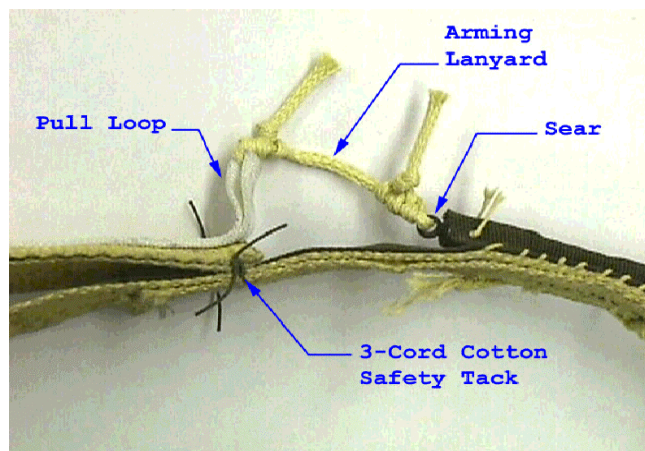
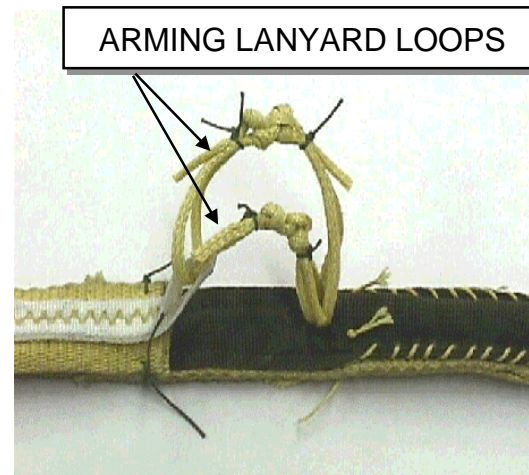
PREVIOUS CONFIGURATION - SINGLE LANYARD NEW CONFIGURATION - TWO LANYARD LOOPS

- Revises reefing release actuation lanyard to provide additional redundancy
 - Provides second (longer) lanyard to actuate the reefing sear (cutter) in the event the first lanyard fails
 - Corrective action from one sear not firing on STS-96 deploy

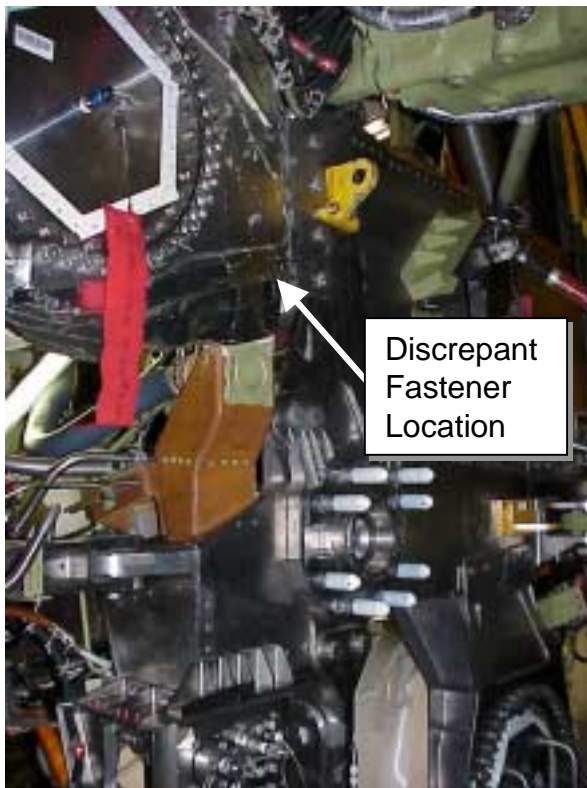
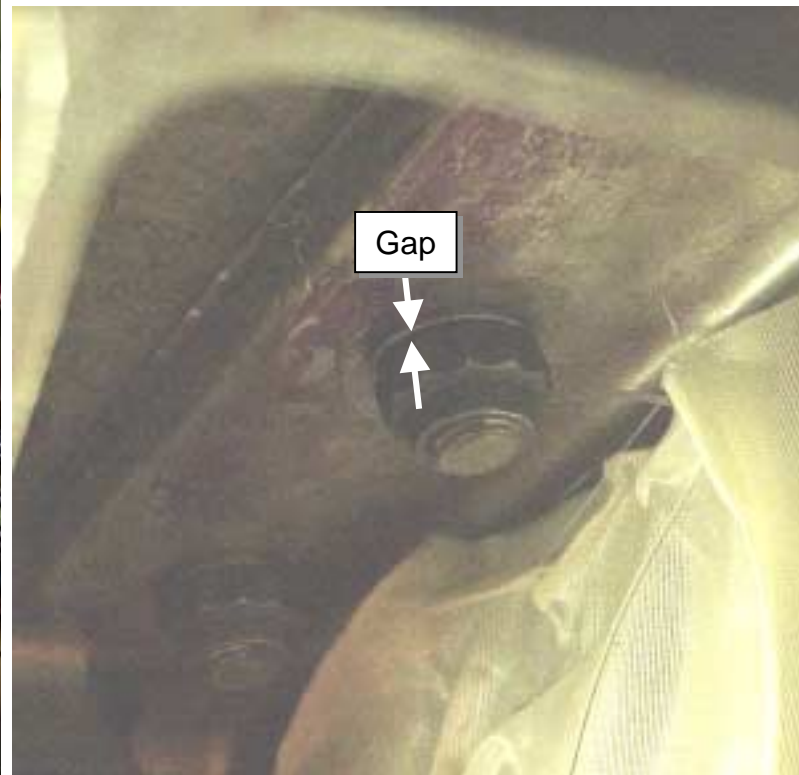
OV-103 LH₂ Feedline Fasteners

- Gap noted under a fastener head and nut on OV-103 LH₂ feedline support

- During V30 structural inspection on OV-103 MPS LH₂ feedline support structure, a discrepant fastener was found
 - Gap under the fastener head was 0.008"
 - Gap under nut was 0.023"
 - Breakaway torque was 30 in-lbs (460-540 in-lbs required)
- Further investigation revealed fastener torque was below specification on all of fasteners on this feedline support

- All OV-104 feedline support fasteners were inspected for thread engagement and gaps and torque was checked on accessible fasteners
 - All of the bolts had proper engagement with lock nut
 - Six small gaps, 0.010" maximum, all less than 180 degrees, implying gaps caused by hole angularity
 - 38 of 81 bolts torque checked – 32 in range, 6 with reduced torque, all at least 60% of specified range

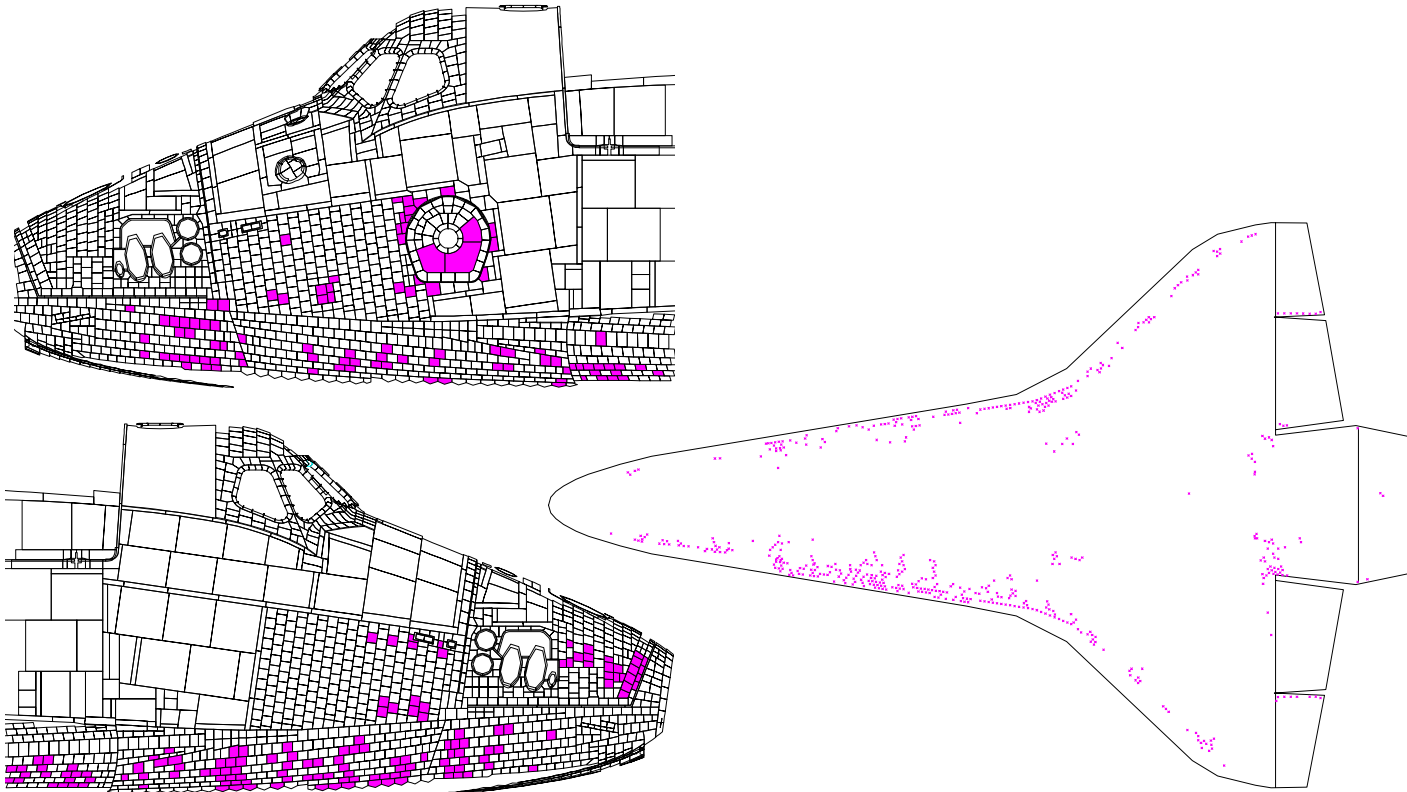
799 ACTIVELY DRIED TILES

- Presence of water during on-orbit operations can lead to freezing and tile fracture

- All OV-104 tiles have been dried and rewaterproofed
 - All wet tiles either dried naturally or were baked a minimum of four hours or until no visible water was escaping
 - Lab testing verified the drying time conservatively protects from potential damage due to freezing
 - Lab and on-vehicle core samples verify tile was successfully rewaterproofed

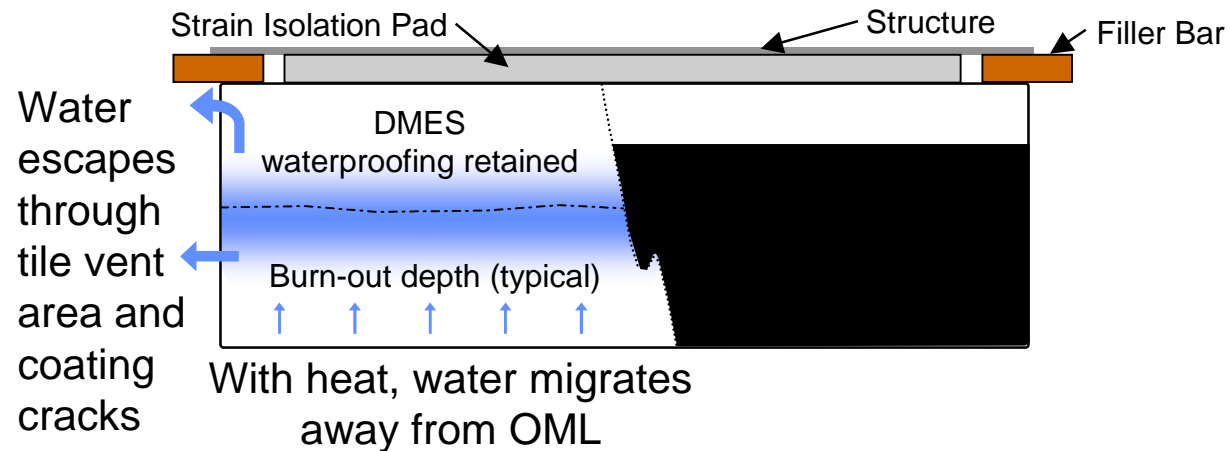
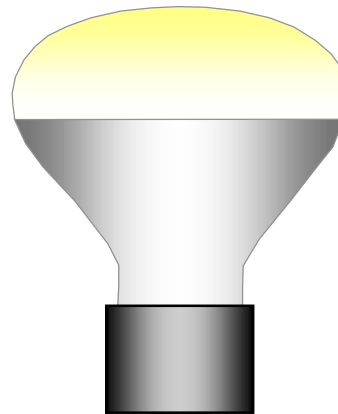
TILE WATERPROOF/DRYING CHARACTERISTICS

Heat lamps are placed immediately adjacent to tile to raise the surface temperature to 250-300°F

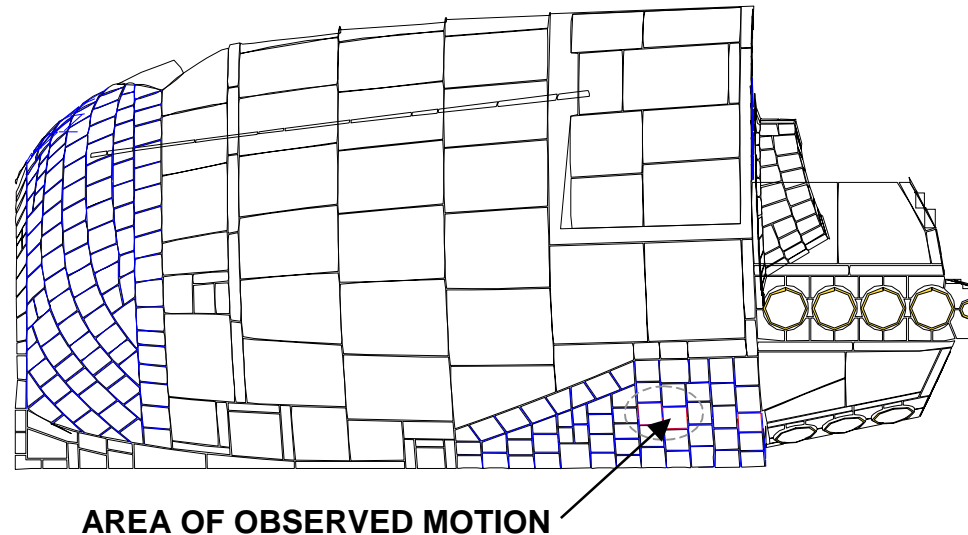
- Left OMS pod vibration observed on STS-100 launch film at SSME startup

- The NASA JSC Image Science & Analysis Group performed film review analysis to define the amplitude and frequency of the LP04 pod movement
 - Two mid-panel points show 72-73 Hz oscillations with maximum peak-to-trough deflections of 0.7 inches (zero-to-peak amplitude of +/- 0.35 inches) in the out-of-plane direction

- The OV-105 left OMS pod structure and TPS were inspected to ensure actual vehicle condition corroborate analytical findings
 - Two TPS tiles near peak amplitude location were removed and show no damage to tiles
 - For these same locations, ultrasound was performed of the outer side of structural panels and no de-bond or de-lamination was found
 - A third tile at the aft frame location (region of peak panel stress) was also removed
 - TPS inspection and ultrasound inspection of the outer structure was performed with no anomalies found
- The pod stinger door was removed and borescope inspection of interior structure was performed with no anomalies found

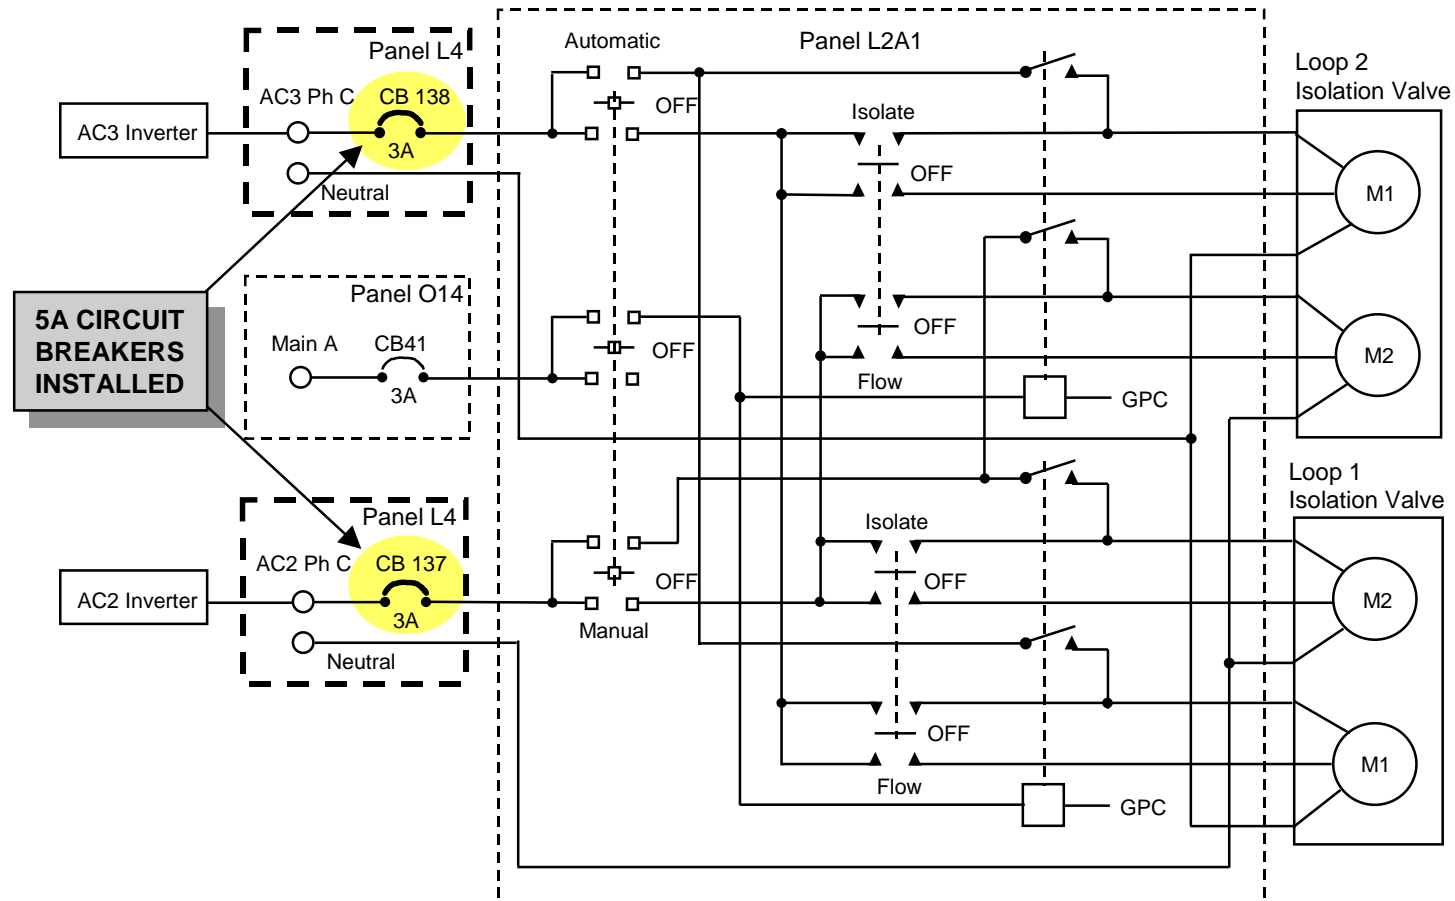
Radiator Isolation Valve Circuit

- The maximum current allowed by a 5 amp circuit breaker could cause an over-current shutdown of the associated inverter if a short in the circuit were to occur

- Circuit stress analysis verified wire is protected under present conditions
- Panel L4 wiring was inspected as part of hinged panel wire inspections - no discrepancies were found
- The OV-104 radiator isolation valves have been cycled to verify circuit integrity
- With a typical short to ground, the 5 amp circuit breaker will protect the circuit
 - A “smart short” (a limited current short that allows the inverter to overload before the circuit breaker trips) could result in an over-current shutdown of the inverter

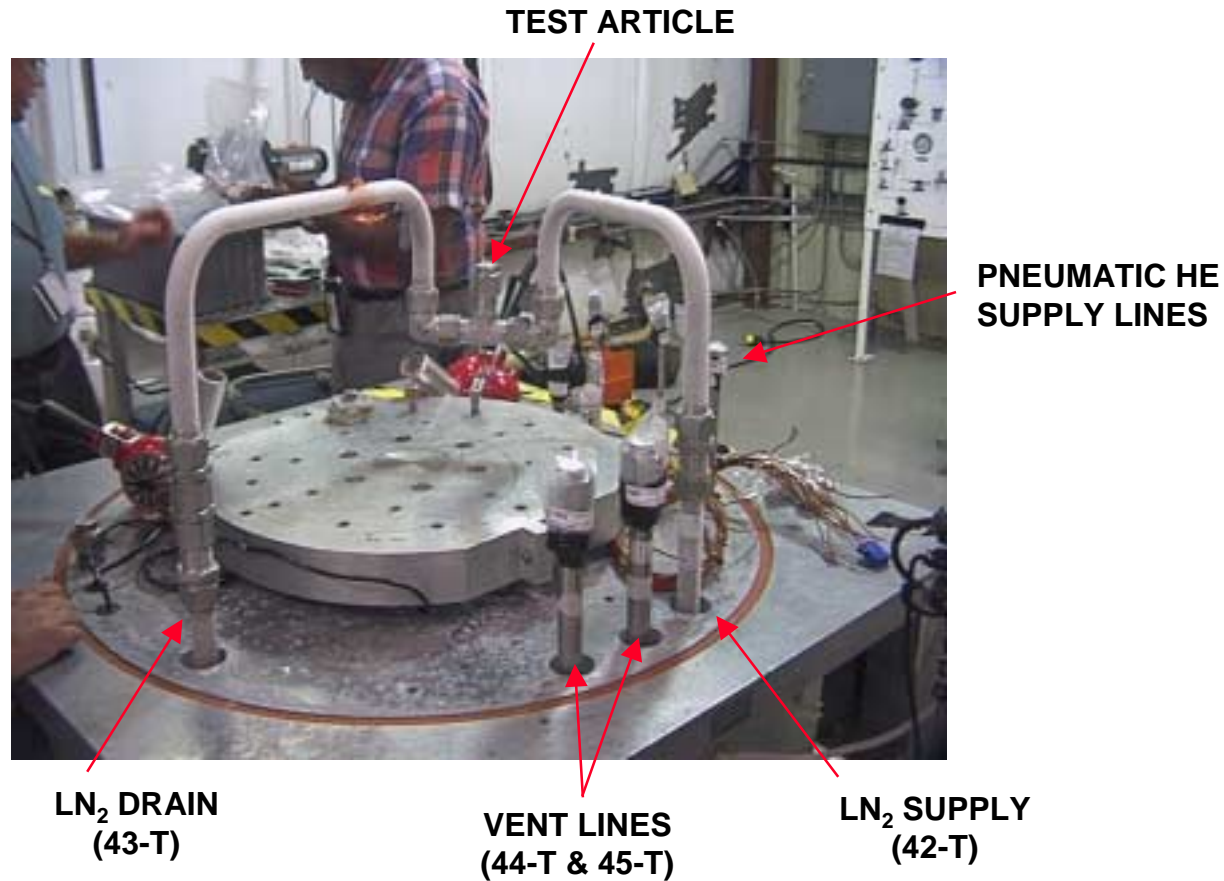
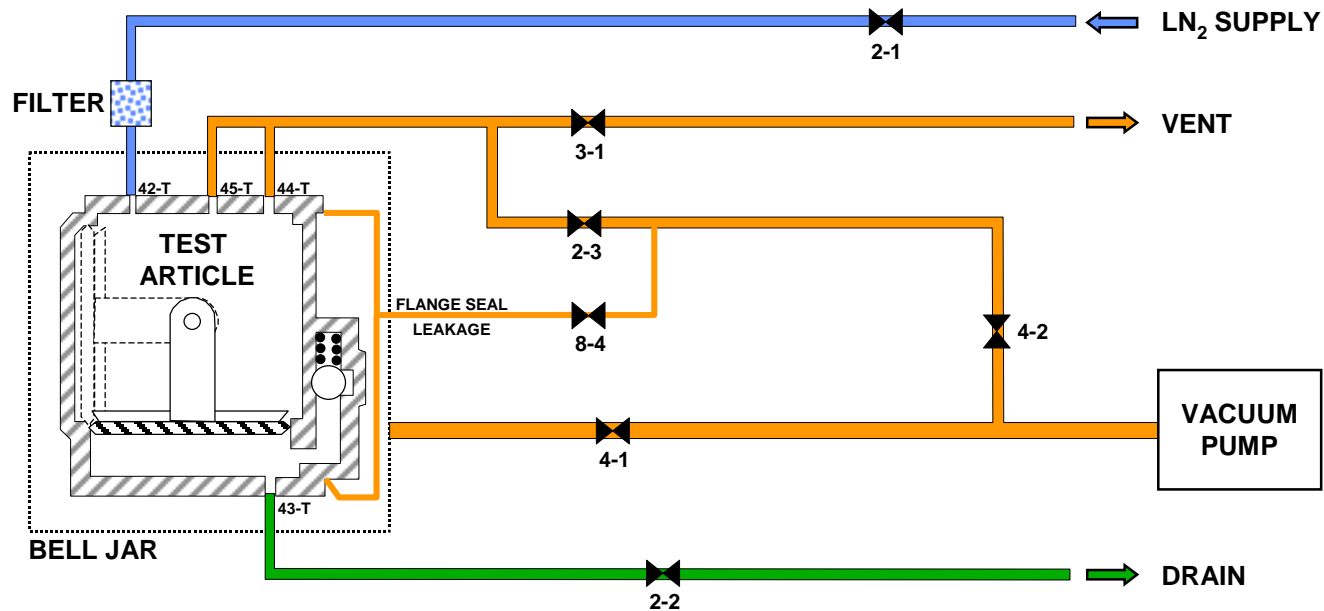
- Performed analysis of contaminant
 - Determined to be double distilled pure hydrocarbon oil with paraffin from vacuum pump on test skid
- Evaluation of test stand configuration revealed a mechanism for oil migration to test articles
 - Pump seal leakage/back diffusion allows introduction of oil into vacuum lines
 - MPS Prevalve ATP exposes flight valve and LN₂ supply system to vacuum source providing path for oil migration
 - Subsequent testing of PRSD panels and MPS Fill and Drain valves exposes test articles to accumulated oil

- Development of cleaning procedure
- Vacuum pump and test configuration evaluation will be performed to determine leakage path and specific transport mechanism
- Other NSLD vacuum applications have been evaluated – no other test configuration exposes LOX hardware to vacuum oil
 - Evaluation in work to determine if any other hardware is at risk due to vacuum pump oil
- Communication with vendors to evaluate potential for similar contamination

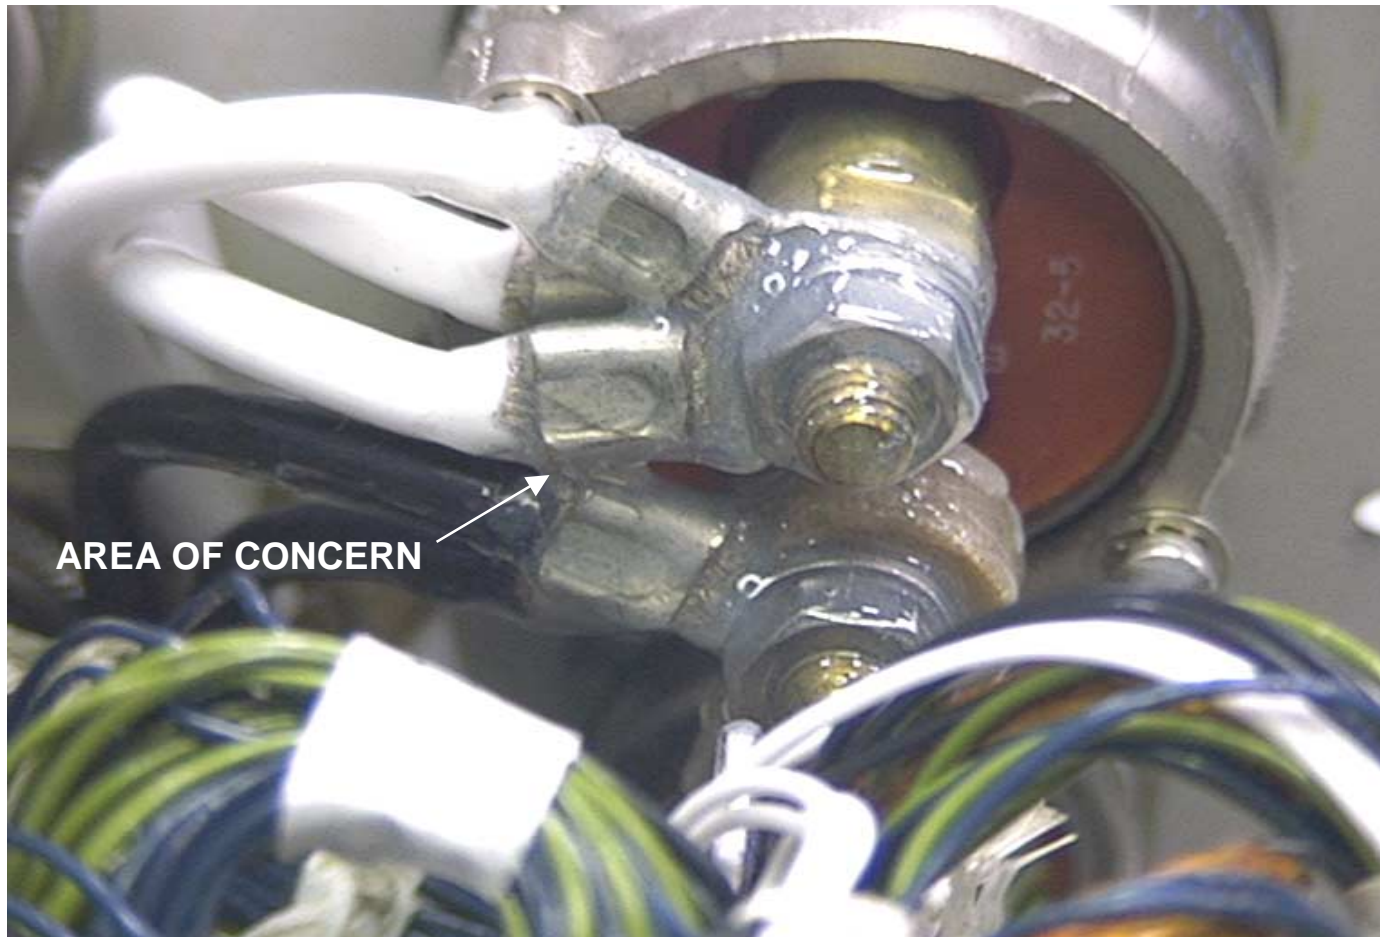
ALCA #3 (S/N MYH0001) CONNECTOR J5 INTERNAL CONNECTIONS

- Aft Load Control Assembly (ALCA) #3, S/N MYH0001 was undergoing repair for a failed hybrid driver when this issue was identified
 - Visual inspections have determined wire lug separation to be approximately 0.080 inches
- ALCA #3 is the OV-102 original build unit delivered in 1978 and has extensive flight exposure
 - From '81 - '92 it flew 10 flights on OV-102 & OV-103
 - From '94 - '01 it flew 11 flights on OV-104

- While ALCAs are considered acceptable for flight, the inspection data showed that several units were not per print – the PRT concluded that the condition of remaining flight units should be investigated
- The EPD&C PRT is developing a follow-on plan to inspect/rework J5 connectors associated with all ALCAs in the fleet
 - Plan to impose MIL-STD-454K inspection requirement on the NSLD via IDMRD

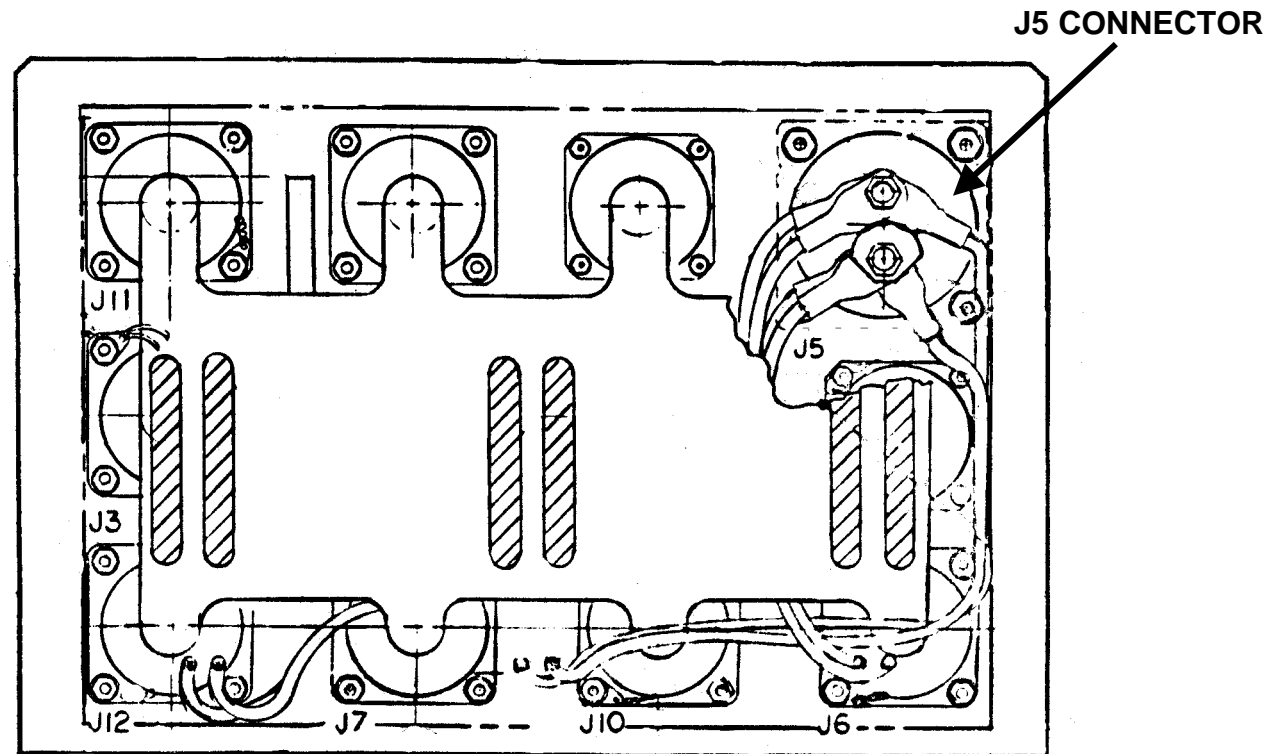
J5 WIRE ROUTING DIAGRAM FROM DRAWING

- Found wire routing was not per assembly drawing
 - Drawing shows one of three wire lugs should be attached from opposite side of J5
 - Although drawing does not specify minimum lug separation, good shop practice is expected
- Reviewed original build data package – no indications of deviations from wire routing requirements per the drawing
- Assessed condition of RTV coating between lugs on S/N MYH0001
 - NSLD reported a solid RTV bridge indicating that there has been no movement or migration of the two lugs in question
- Evaluated other EPDC LRUs to determine if this condition may exist elsewhere – only the ALCAs employ this wire termination design

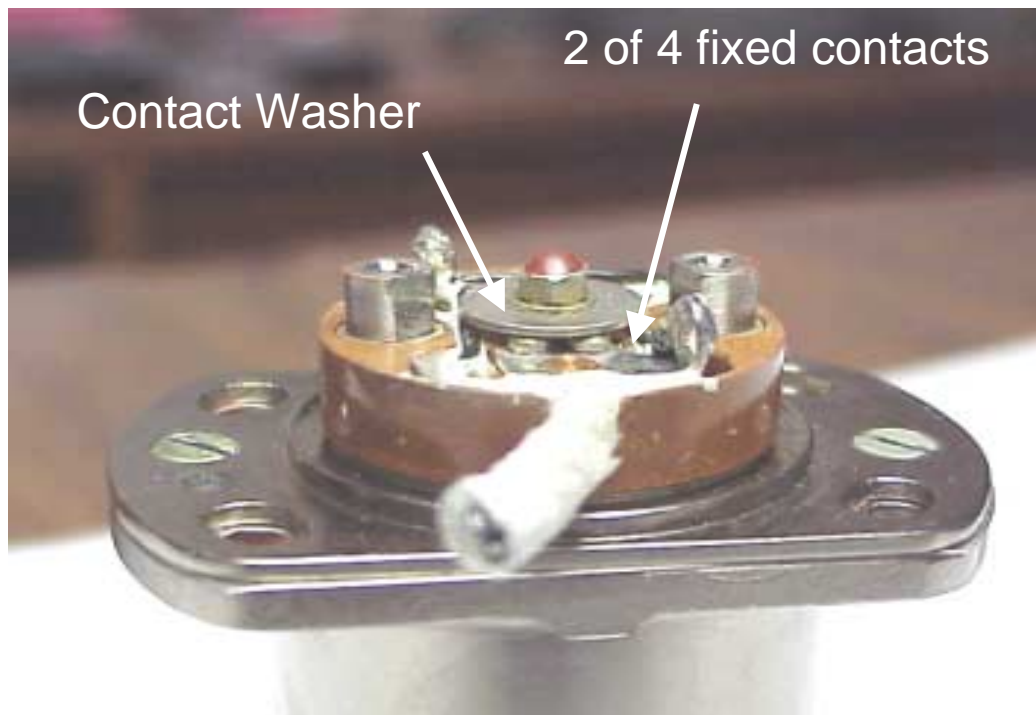
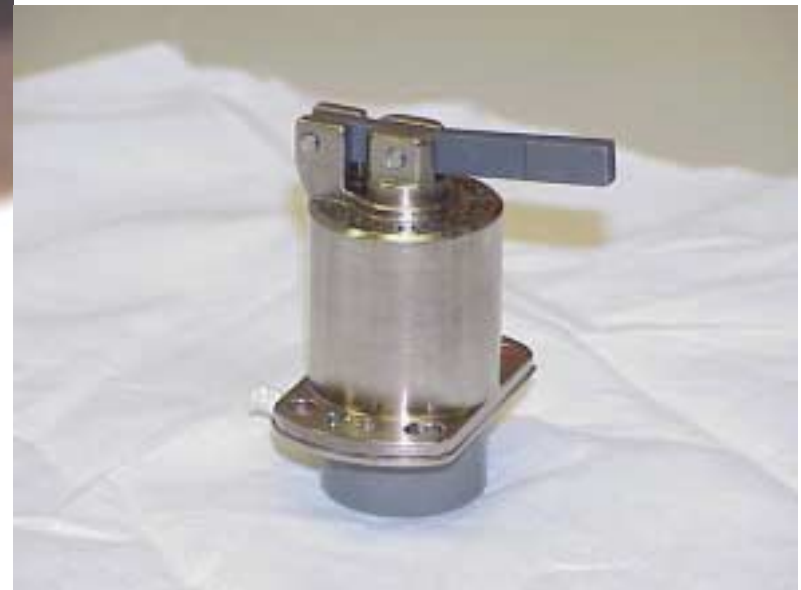
Fixer Contact Washer Subassembly

- During routine OPF testing, Fixer #1 failed to engage
 - RSC-E representative was present and verified failure

- Troubleshooting isolated failure to the Contact Washer Subassembly
 - Switch was stuck in the open position - unable to apply start up current to fixer
 - This Contact Washer Subassembly is common to all ODS Fixers
- Assembly level tests of the fixer performed at RSC-E. Fixer was completely disassembled and piece parts inspected.
- Approximately 100 cycles were applied.
 - Anomaly repeated 1 time
 - RSC-E attempted to repeat the failure by manipulating the Contact Washer Switch but was unsuccessful
- Analysis findings:
 - 0.006 difference in contact heights
 - Contact washer sub assembly had some misalignment
 - Contact washer sub assembly could rotate on its axis
- RSC-E conclusion is that all three findings combined to result in the failure.
 - Additional discussion has identified that the manufacturing tolerances are insufficient – design changes for future builds under review

- RSC-E performed R&R on May 8 and 9, new fixer installed and functioned properly, remaining ODS testing completed with no issues
- This failure can not result in a fixer failing on
 - Failed on fixer could result in hardware damage, due to non-compliant mechanism
- Failed fixer is only an issue when the docking system experiences energy (momentum) buildup within the kinematic chain resulting from a stuck damper, which can create significant (4% to 7%) linear misalignment
- Current flight procedures require crew to stop ring motion if RING ALIGN light on AFD panel goes out. Limits linear misalignment to 3% prior to motion stop
- Natural stiffness of system will realign the ring
- Current experience is that realignment motion unsticks dampers
- Fixer failure is unlikely, operational controls in place.
- ODS is ready for STS-104

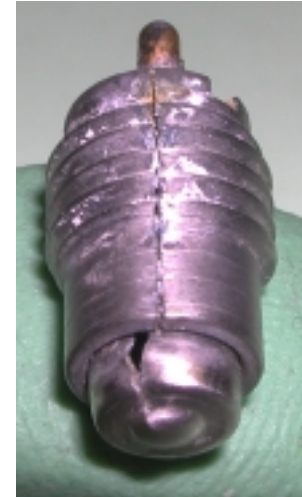
Cracked Primer Plug

- Unit that failed during training (1992 unit) was disassembled
 - Crack was found in the primer plug, which houses the primer containing the pyro charge
 - Allowed charge to not properly puncture the end of the primer and gas expelled in the reverse direction, thus causing damage to the housing
- Cracks were found in 5 additional 1992 units, all exhibiting the same failure pattern
- No cracks were noted in any of the 1997 units
- Different stainless steel lots and suppliers were used in the 1997 builds
- Failure points toward defective material stock used in 1992 builds
- Metallurgical analysis of stainless steel used in the 2 lots notes hardness differences between lots and sites ductile failure by tensile loads as the root cause of the 1992 lot unit cracks
- No history of this type of failure previously exists
- Backup manual activation system is unaffected by this type of failure
